TECHNICAL SERVICE POINTER

Technical Service Pointer: W11282589

Air Dome Pressure Sensor Pulling Loose / Cracking

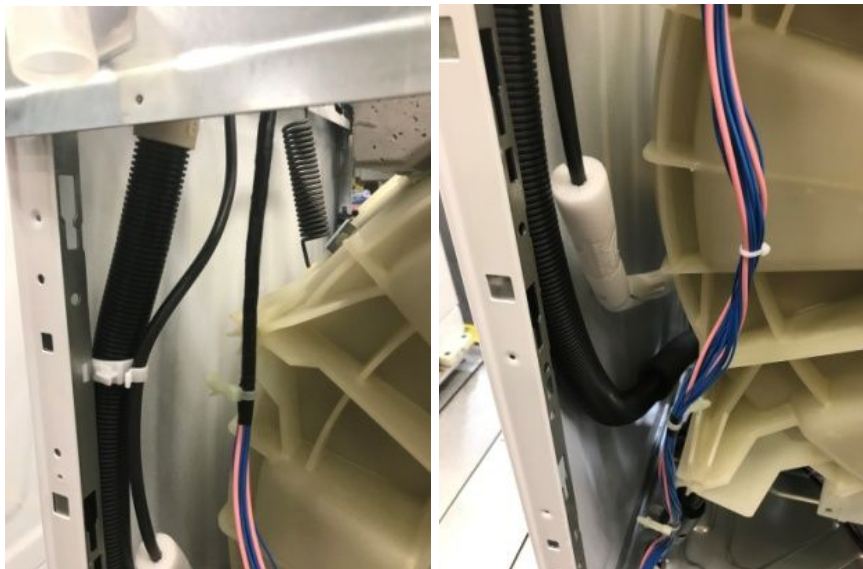
During some severe unbalance occurrences, the hose attached to the pressure sensor may chafe where it is zip tied to the machine (MHN30 and MLE / MLG20). On other machines, the hose may pull off of or crack the nipple of the pressure transducer (MHN33 and MLE / MLG22).

Production Correction
